PRELIMINARY REPORT

HIGHWAY

HWY14MH006

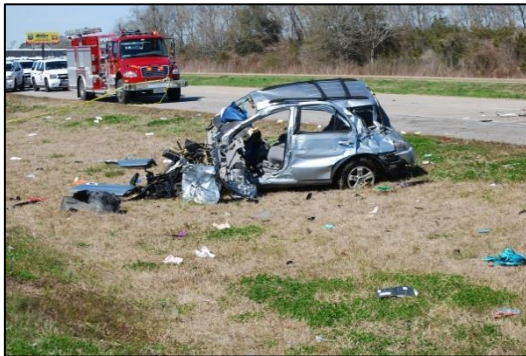
Figure 1: Kia final rest position

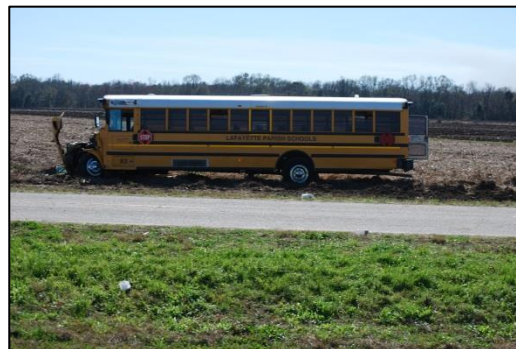
Figure 2: School bus final rest position
